**Investigation of the Causes of Deformation Processes at  
Industrial Construction Sites and Methods  
of Geotechnical Rehabilitation**

**Abstract.** This paper investigates the causes of intensive structural deformations and differential settlements recorded at the construction site of an insulation board manufacturing plant. Based on comprehensive visual-geotechnical monitoring, diagnostic engineering-geological surveys, and a rigorous retrospective analysis of previously obtained laboratory data, it was established that the lithology of the underlying soils is represented by moisture-sensitive, poorly compacted loessial silty clay soils. Retrospective verification calculations showed that 14 out of 21 sampled soil specimens exhibit pronounced collapsible properties upon wetting, which allows classifying the site's ground conditions as Type II collapsible soil conditions. The primary catalysts for the developing structural damages were recognized as technological violations during backfill compaction operations, insufficient hydraulic slopes of protective concrete aprons, and the complete absence of functional stormwater drainage networks, which led to total surface water infil

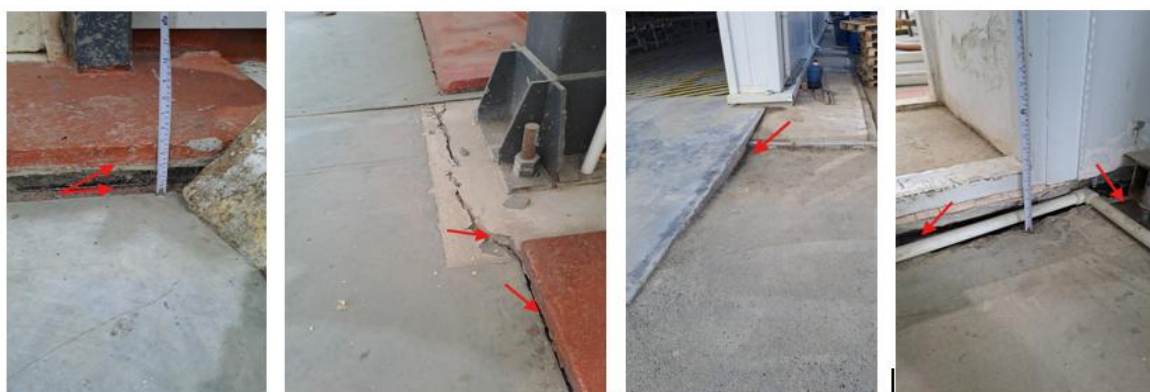
Local geotechnical monitoring, engineering-geological diagnostics, and technical safety assessments performed along the plant's perimeter revealed several critical lithological anomalies and structural defects. Within the soil strata underlying the foundation beds of the industrial complex, signs of active vertical displacement deformations (Figure 2) were clearly recorded, namely intensive settlements and differential collapse profiles (An et al., 2022).

**Figure 2**  
*Foundation deformation*  
 Source. Authors.

To eliminate foundation deformations of heavy processing equipment, various scenarios are possible: mechanical foundation reconstruction, stabilization via Jet Grouting (Shen et al., 2020), pile foundation upgrading, or precision equipment alignment. Thus, the proposed complex of measures combines engineering-geological diagnostics, advanced soil remediation methods, and hydrotechnical protection, ensuring risk reduction and enhancing the resilience of the industrial infrastructure.

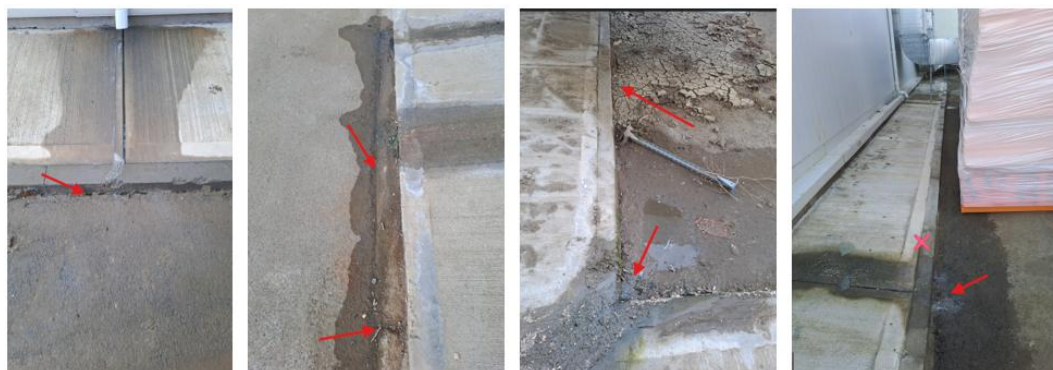
Following the completion of the main structural construction works, site preparation and backfilling activities (specifically, the compaction of excavation trench and foundation pits adjacent to reinforced concrete foundations) were executed without proper geotechnical engineering supervision.

The backfill materials were not compacted to the required maximum dry density values, creating an artificial, highly porous medium that catalyzed active infiltration (Figure 3) of industrial and stormwater runoff into the primary underlying soil mass.

**Figure 3**  
*Infiltration of industrial and stormwater*

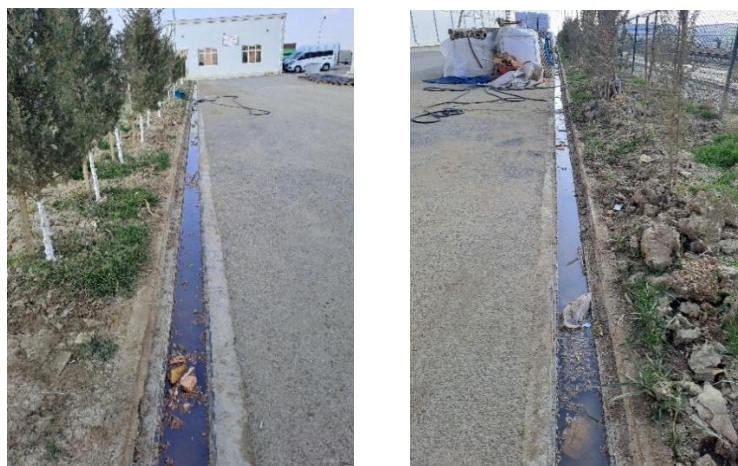
The production areas of the insulation board workshops and auxiliary elements in direct contact with the underlying soil matrix, as well as the isolated foundations of the steel frame columns, lacked sufficient engineering protection against exogenous, anthropogenically induced hydrogeological hazards. Perimeter protective concrete aprons (waterproof pavements) lacked the standard hydraulic slopes necessary to divert surface runoff away from load-bearing elements, resulting in localized water ponding (Figure 4).

Post-construction engineering solutions designed to isolate the highly moisture-sensitive loess formations from atmospheric precipitation (particularly heavy rainfalls) lacked structural-functional justification and completely ignored the internal hydrostructural instability inherent in the foundation substrate. Many historical failures in loess regions occurred because standard surface water-defense measures (like concrete aprons or drainage ditches) were designed as isolated superficial solutions. Designers failed to account for the internal microstructural collapse triggering mechanism when continuous rainwater infiltration bypasses these barriers (Li et al., 2016).

**Figure 4**  
*Localized water ponding*

The final selection of the remediation scheme must be based on rigorous numerical modeling that accounts for predicted settlement, moisture migration pathways, and structure-utility interactions. Additionally, alternative stabilization methods can be considered—dynamic compaction, controlled collapse, chemical grouting, or thermal treatment. An integral part of the strategy is the reconstruction of the surface water management system, including the design of a closed high-capacity stormwater network and the construction of protective concrete aprons at least 2.0 m wide. These measures must be accompanied by replacing the wet backfill soils with compacted clayey materials and constructing drainage channels directing runoff away from the site.

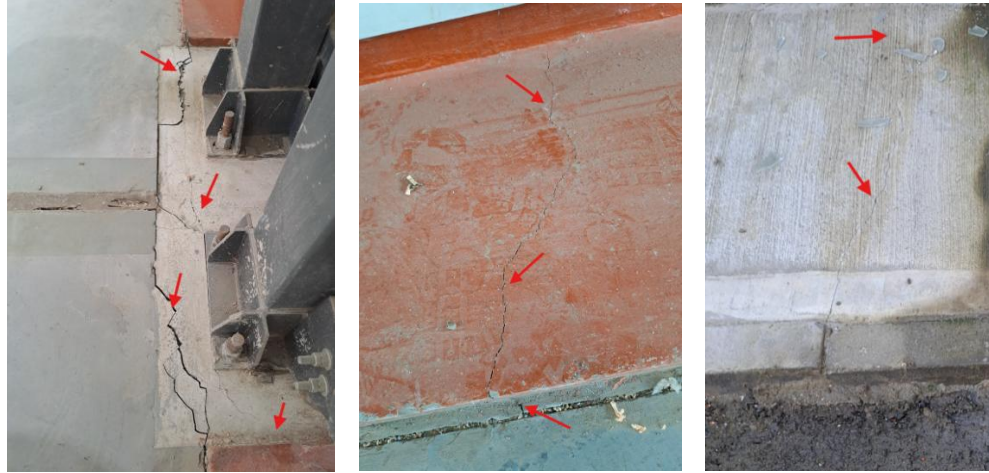
Major macro-fissures and multi-directional structural cracks with varying aperture widths were mapped across load-bearing structural elements, reinforced concrete partition walls, and concrete drainage channels (Figure 5). Monolithic reinforced concrete floor slabs serving as foundations for heavy industrial equipment demonstrated significant differential settlements accompanied by micro-cracking.

*Major macro-fissures and multi-directional structural cracks*

Due to malfunctioning downspouts, atmospheric precipitation collected from extensive roofing systems was systematically discharged directly into these open cracks in the concrete, causing total vertical infiltration into the underlying collapsible loess layers (Li et al., 2016). The existing subsurface drainage system and the stormwater collection network were quantitatively and volumetrically inadequate for the catchment area of this facility. The only operational drainage outlet on site was found to be completely decommissioned due to severe internal siltation (clogging) and a total loss of the design hydraulic slope.
